**Highpoint Pipeline Condition
Assessment Vallecitos Water District
FINAL DRAFT
TECHNICAL MEMORANDUM**

Subject: **Summary of Condition Assessment Results and Recommendations**

HIGH POINT WATERLINE CONDITION ASSESSMENT

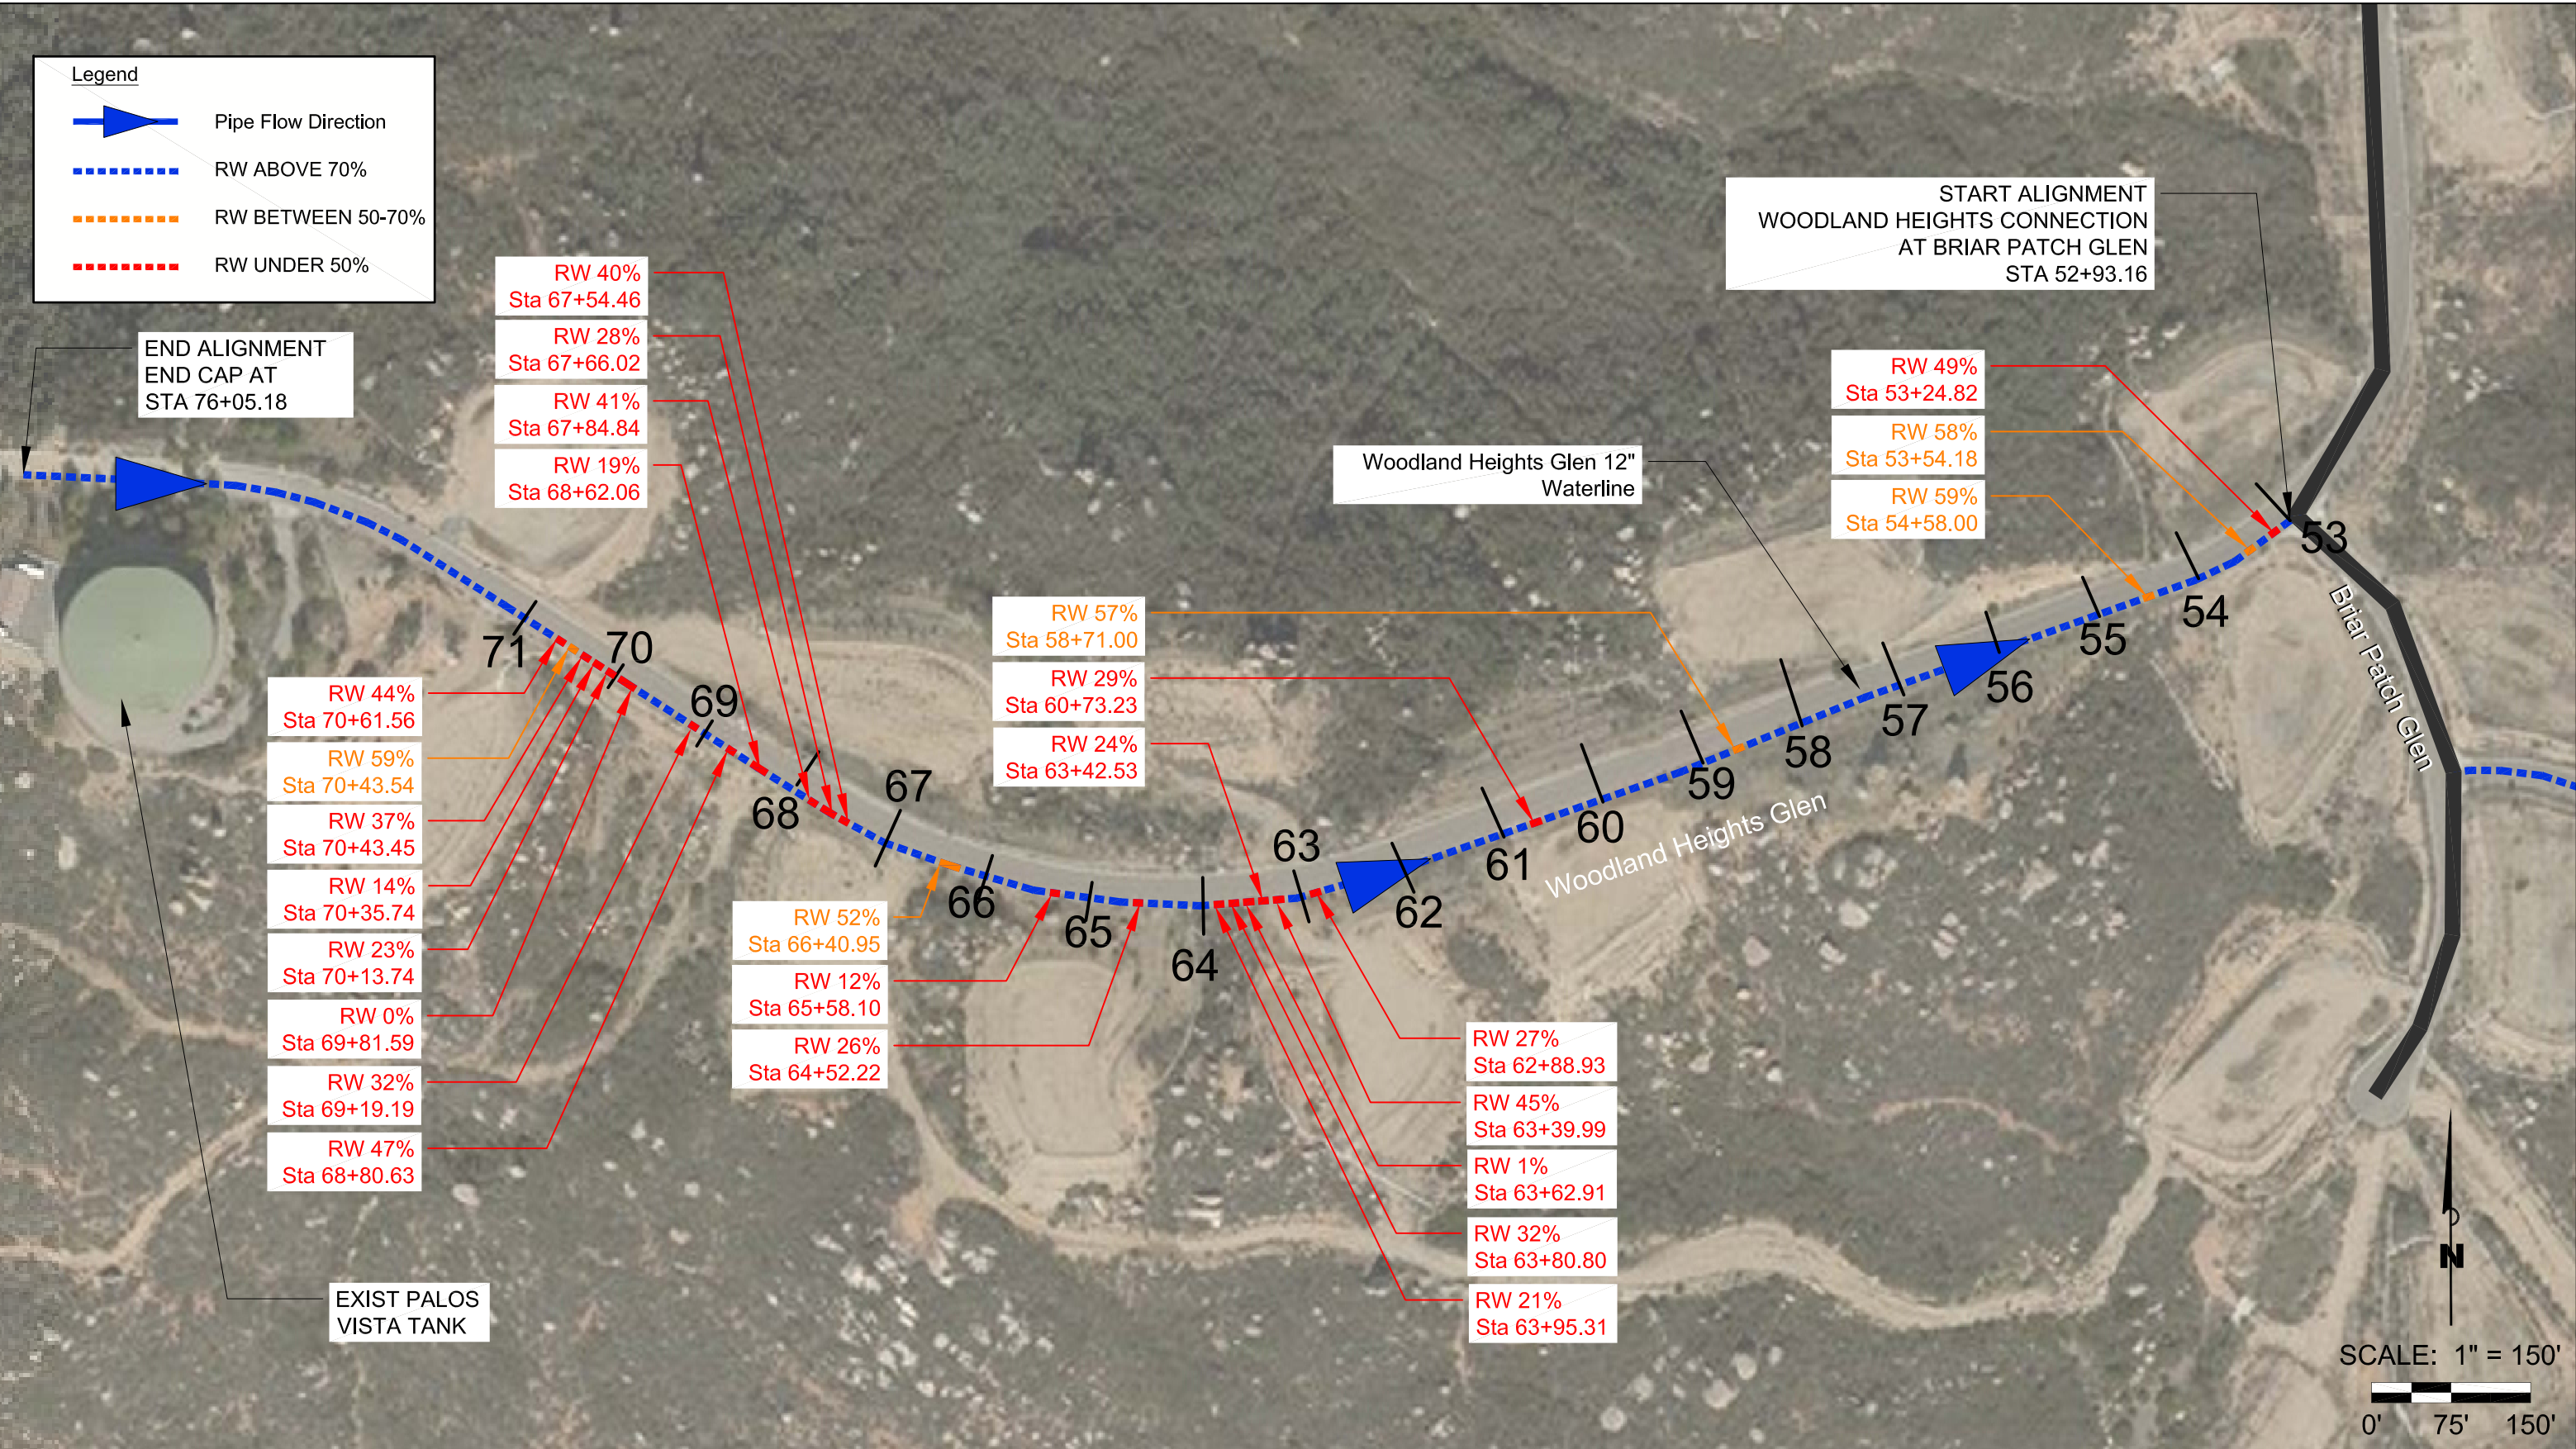
FIGURE 1: WOODLAND HEIGHTS GLEN DEFECT LOCATIONS

1. The 8-inch diameter line in Kensington Glen was found to have three (3) pitting indications.
2. The 12-inch diameter line in Woodland Heights Glen was found to have thirty-four (34) pitting indications.

Using a 200 psi working pressure, the minimum allowable remaining wall in the existing DIP would be 70%. Of the 34 pitting locations identified in the 12-inch diameter Woodland Heights Glen pipe, 30 were found to have less than 70% remaining wall. The three pitting locations found in the 8-inch diameter Kensington Glen pipe; one was found to be at 70% of remaining wall; the others greater than 70% remaining wall.

Based on the inspection findings and subsequent calculations and analysis, there is a substantial pattern of premature failure in the 12-inch Woodland Heights Glen pipe and additional pitting locations can be expected in the uninspected portions of pipe. With an approximate projected total of 200 pitting locations in the 12-inch Woodland Heights Glen pipe spot repairs or surgical replacement of pipe sticks may not be practical in that unintended damage to adjacent pipe may be unavoidable and additional leaks encountered as an unintentional consequence and the entire piping system may be compromised. A more efficient and better long term solution would be to simply remove the entire linear footage of 12-inch ductile iron pipe and replace it in the same alignment with new 12-inch diameter AWWA C-900 PVC pipe and fittings that is procured and installed in accordance with District standards and subject to a rigorous construction inspection process by District staff. Existing services and appurtenances can likely be re-connected to the new pipeline.

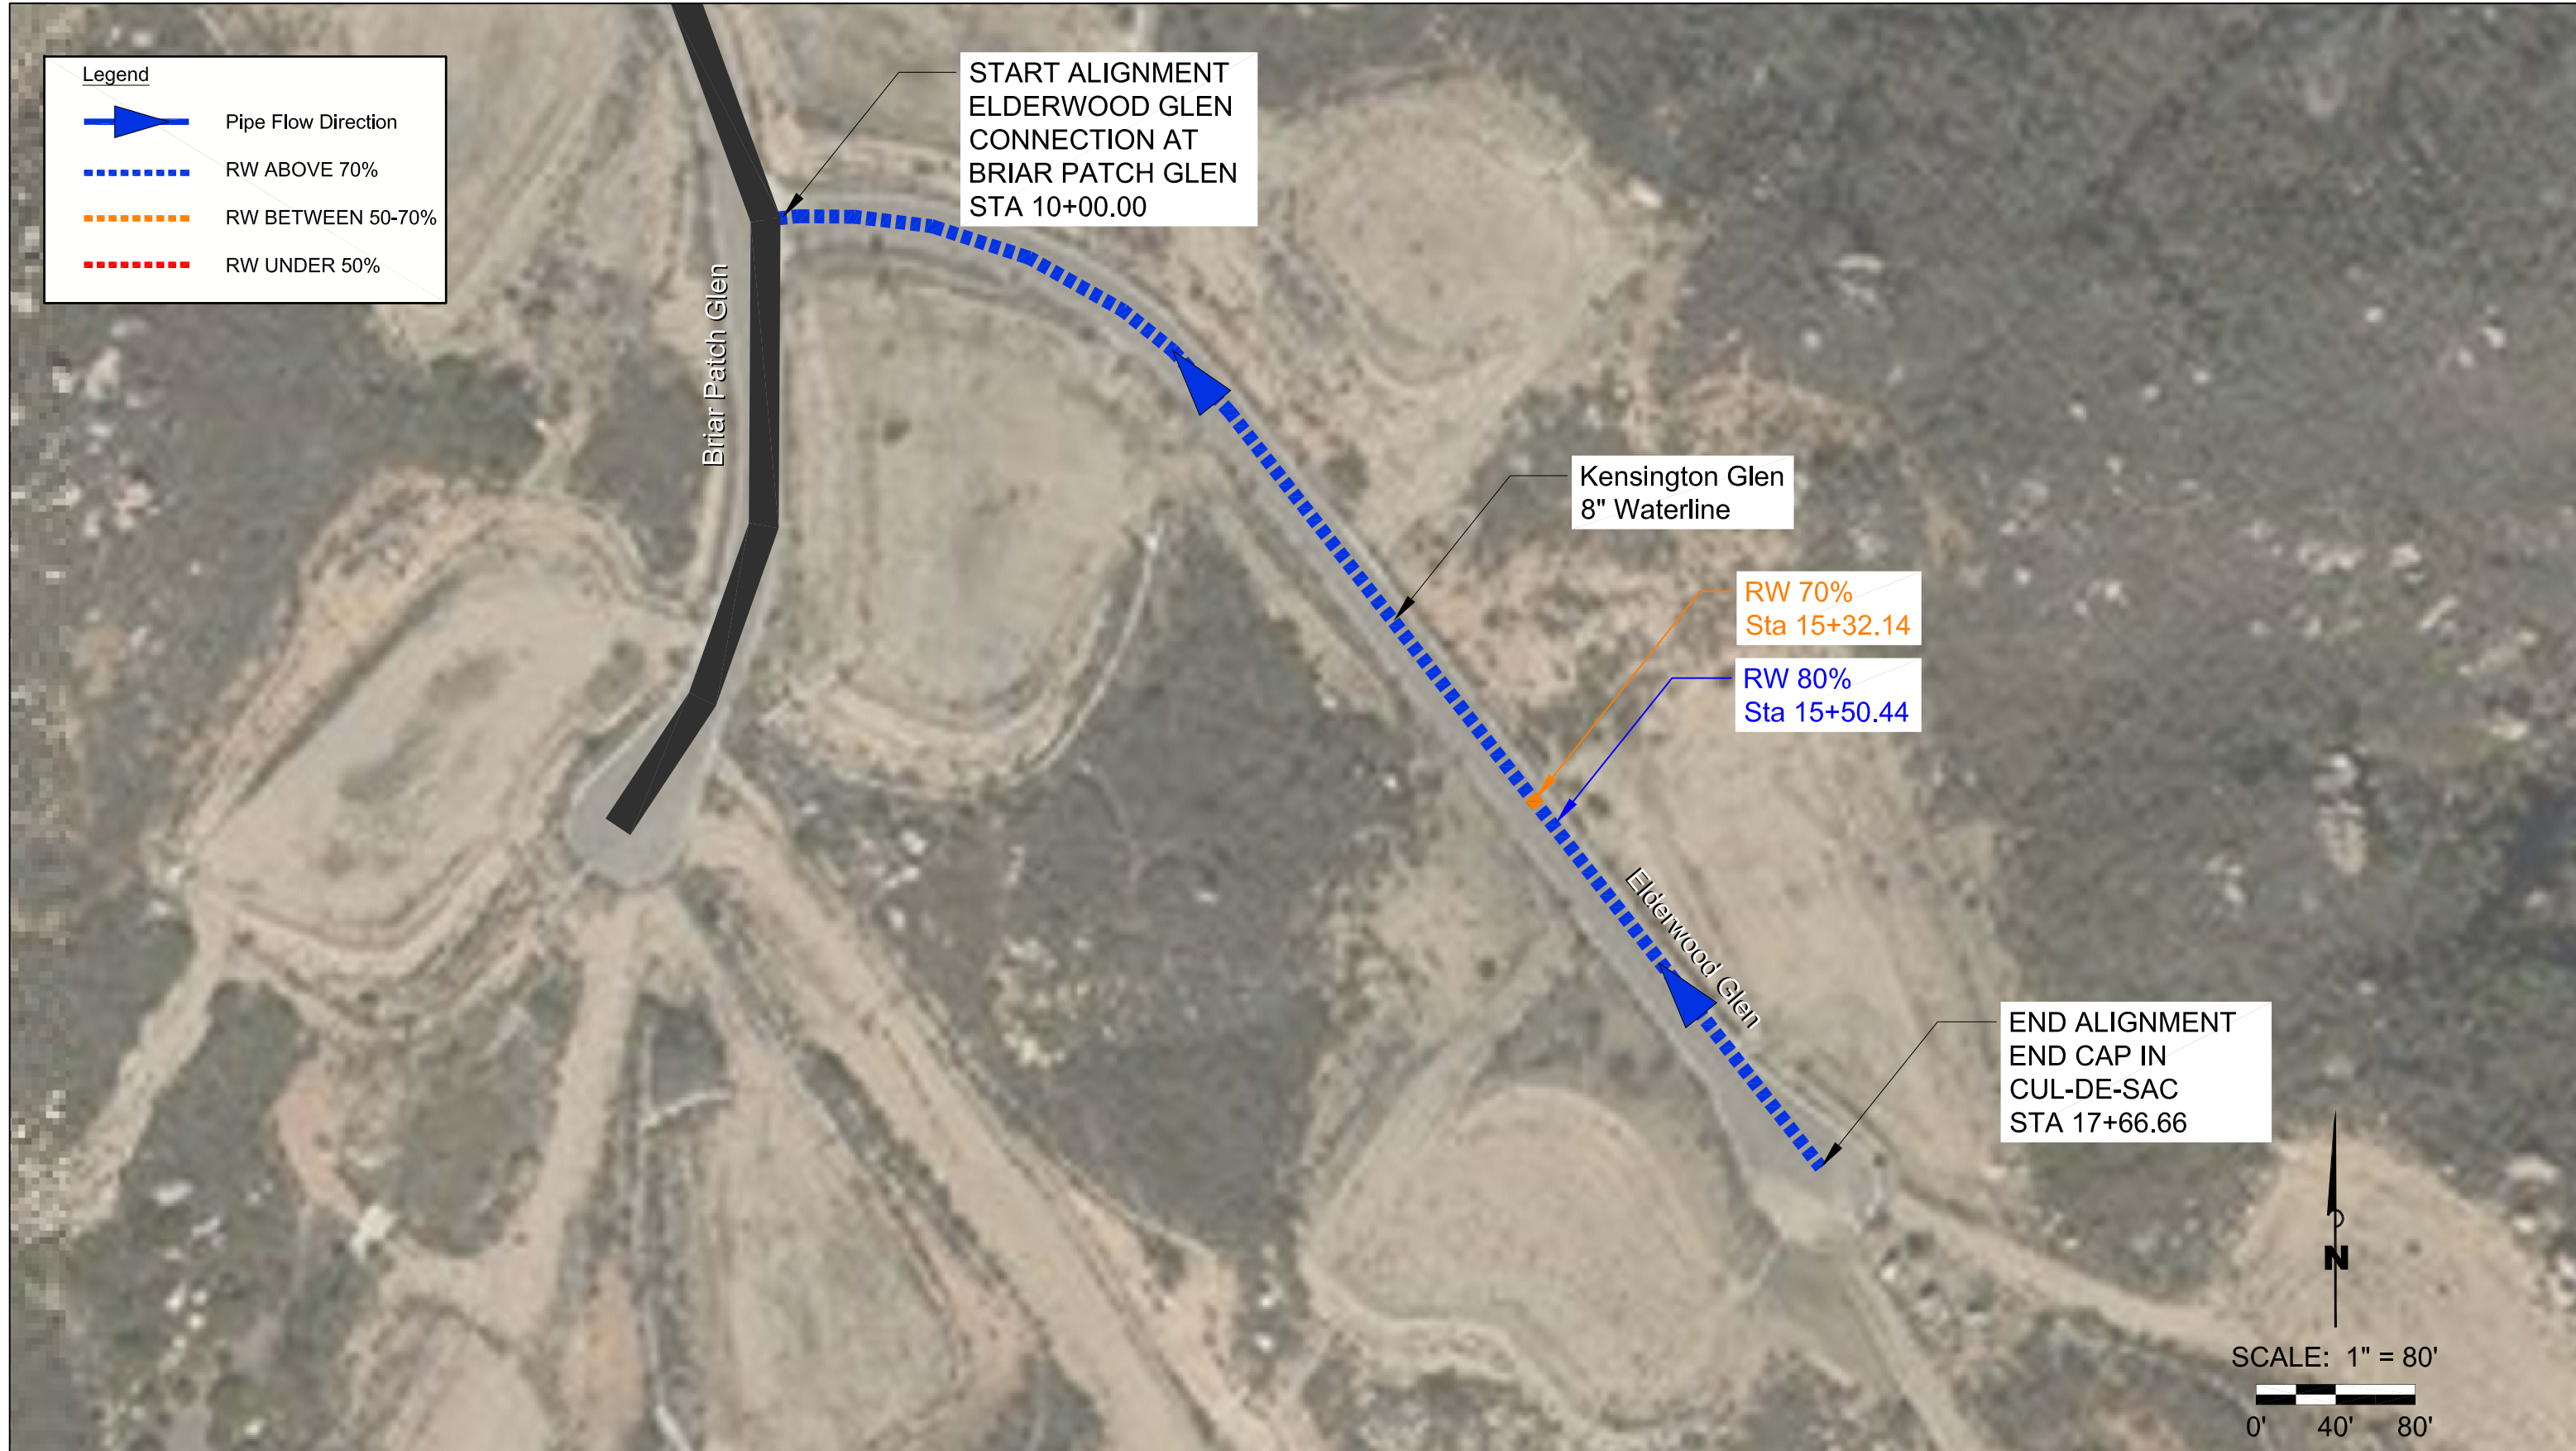
FIGURE 2: KENSINGTON GLEN DEFECT LOCATIONS

The 8-inch ductile iron pipe on Kensington Glen is in considerably better condition and did not exhibit pipe sections with less than 70% remaining wall. Consideration should be given to inspecting the remaining portions of 8-inch pipe at the site to determine its condition.

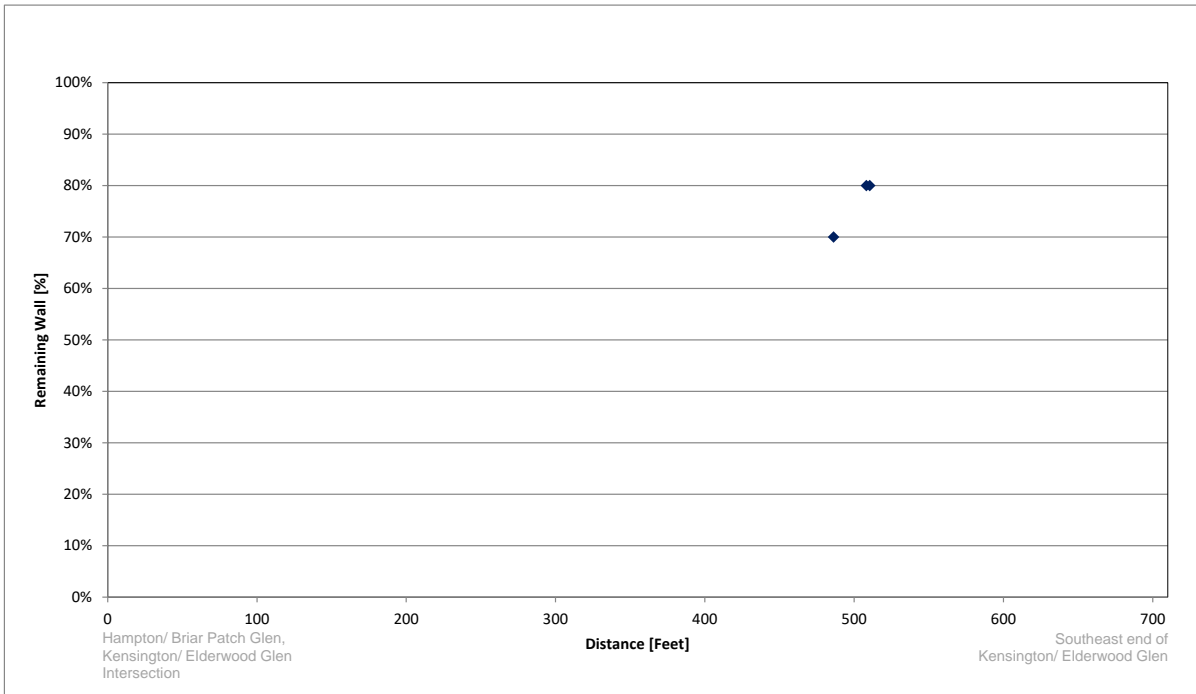
Figure 1a: Distribution of wall loss with respect to remaining wall (%NWT) in pitting regions along the inspected section of the 8” Kensington Glen DI Watermain.

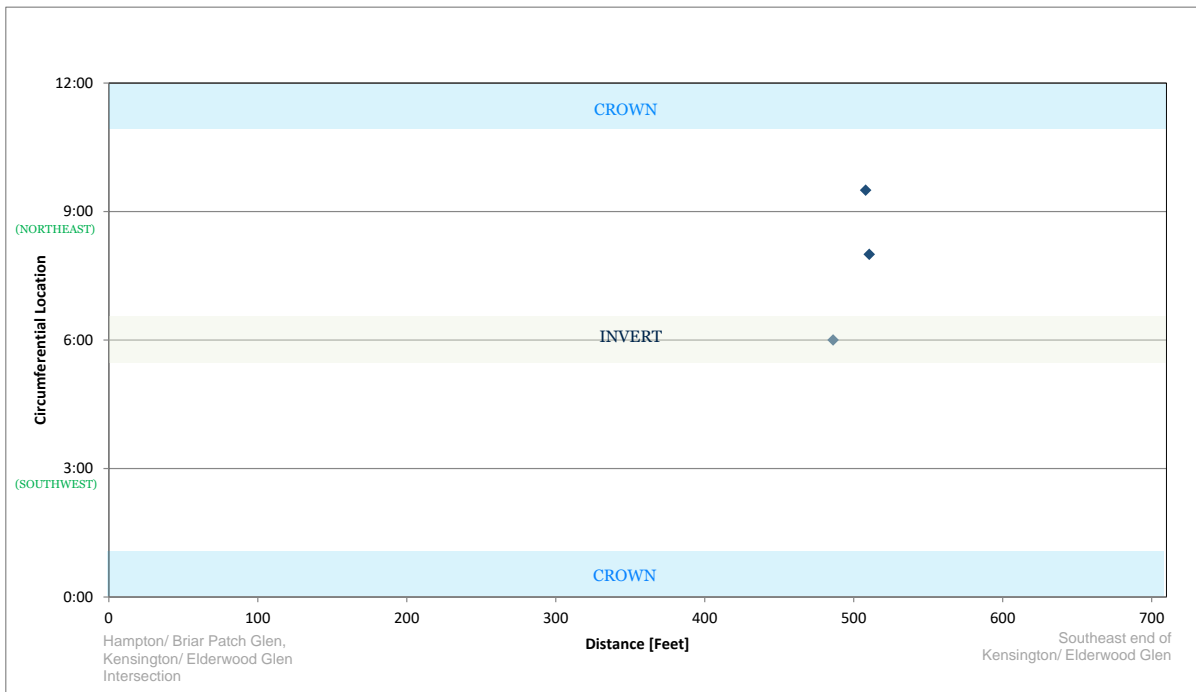
Figure 1b: Circumferential distribution of pitting regions along the inspected section of the 8” Kensington Glen DI Watermain.

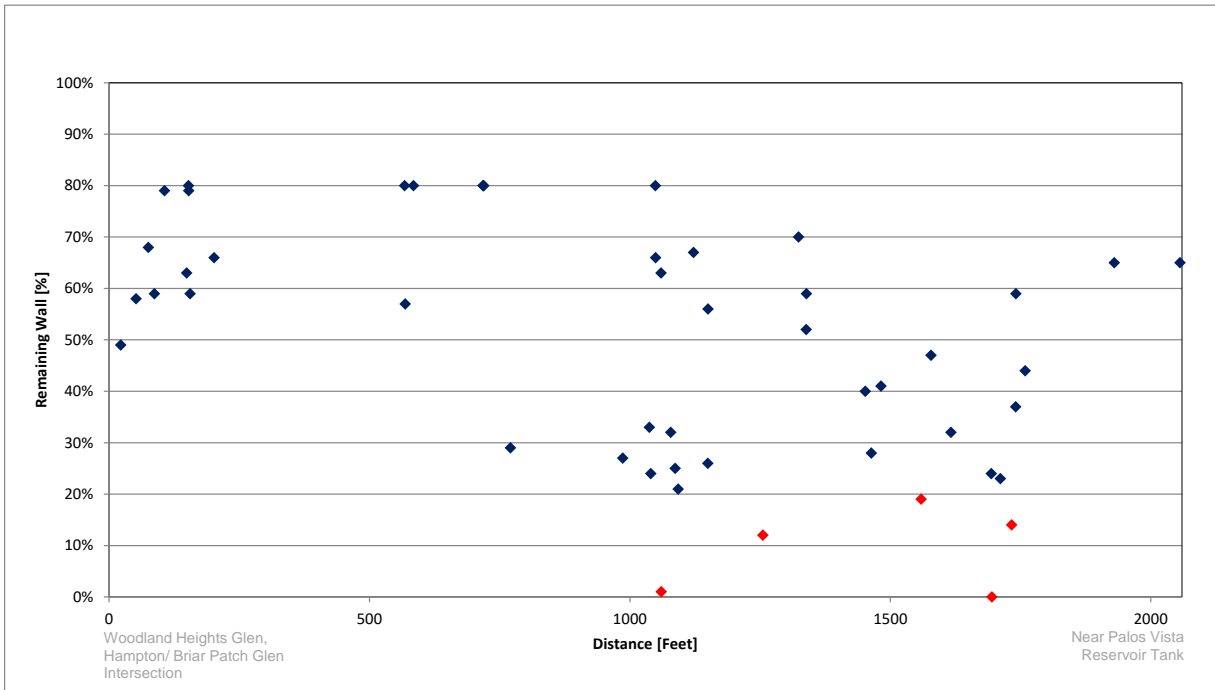
Figure 2a: Distribution of wall loss with respect to remaining wall (%NWT) in pitting regions along the inspected section of the 12” Woodland Heights Glen DI Watermain.

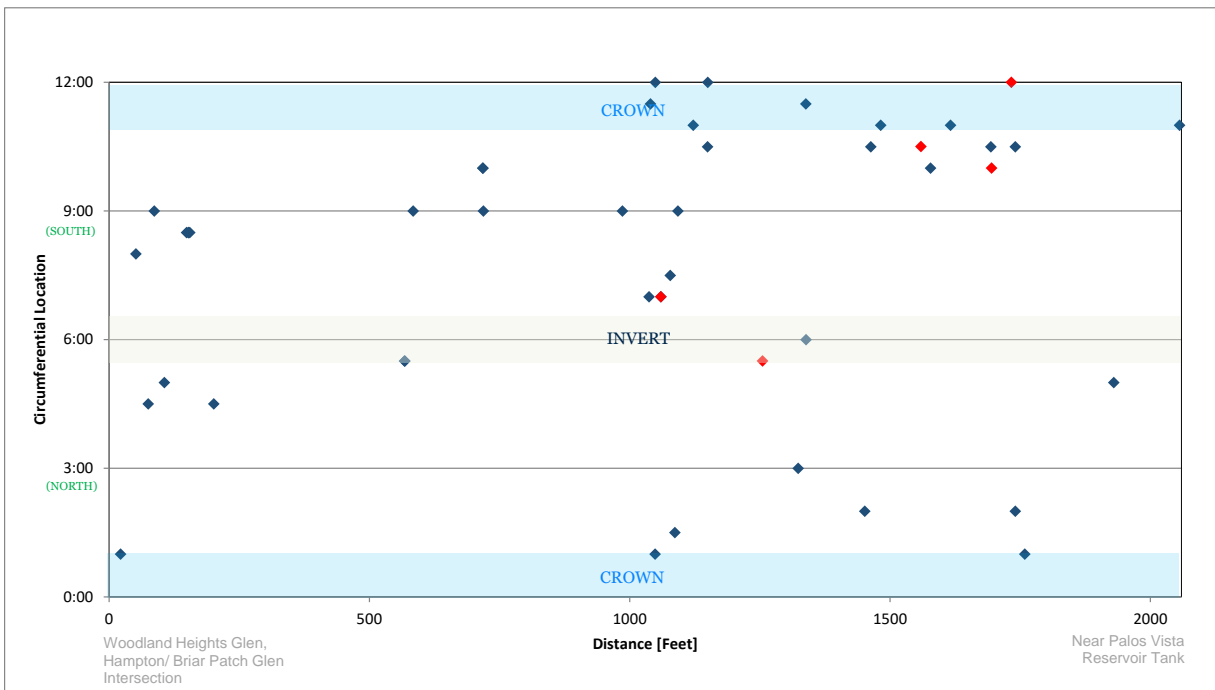
Figure 2b: Circumferential distribution of pitting regions along the inspected section of the 12” Woodland Heights Glen DI Watermain.

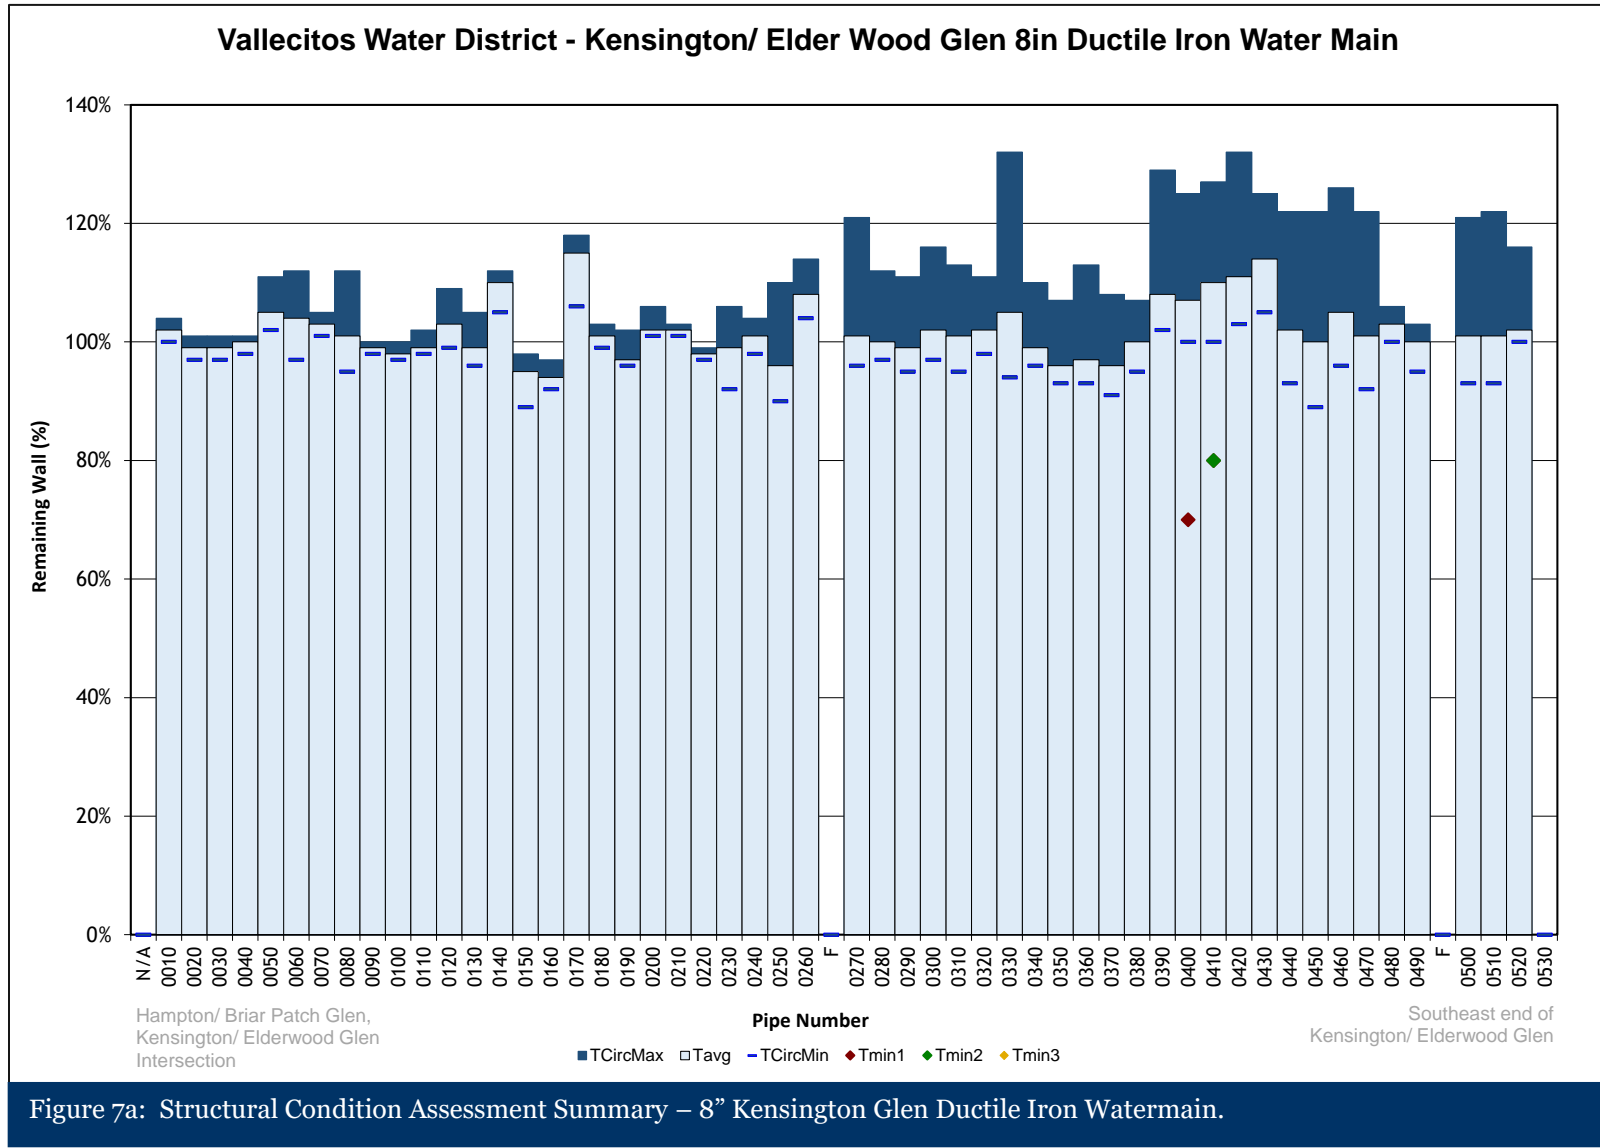
A total of three (3) pitting indications were identified in two (2) pipe segments, all measuring 70% remaining wall (RW) or more. The two shallowest indications, both measuring 80% RW and found in Pipe 0410, are reported with lower confidence due to being small volume indications. Table A1 in the Appendix details the three worst pitting indications per pipe (T_{min1} , T_{min2} and T_{min3}) in this section. The same results are shown graphically in Figure 7a on page 16.

Figure 7a: Structural Condition Assessment Summary – 8” Kensington Glen Ductile Iron Watermain.

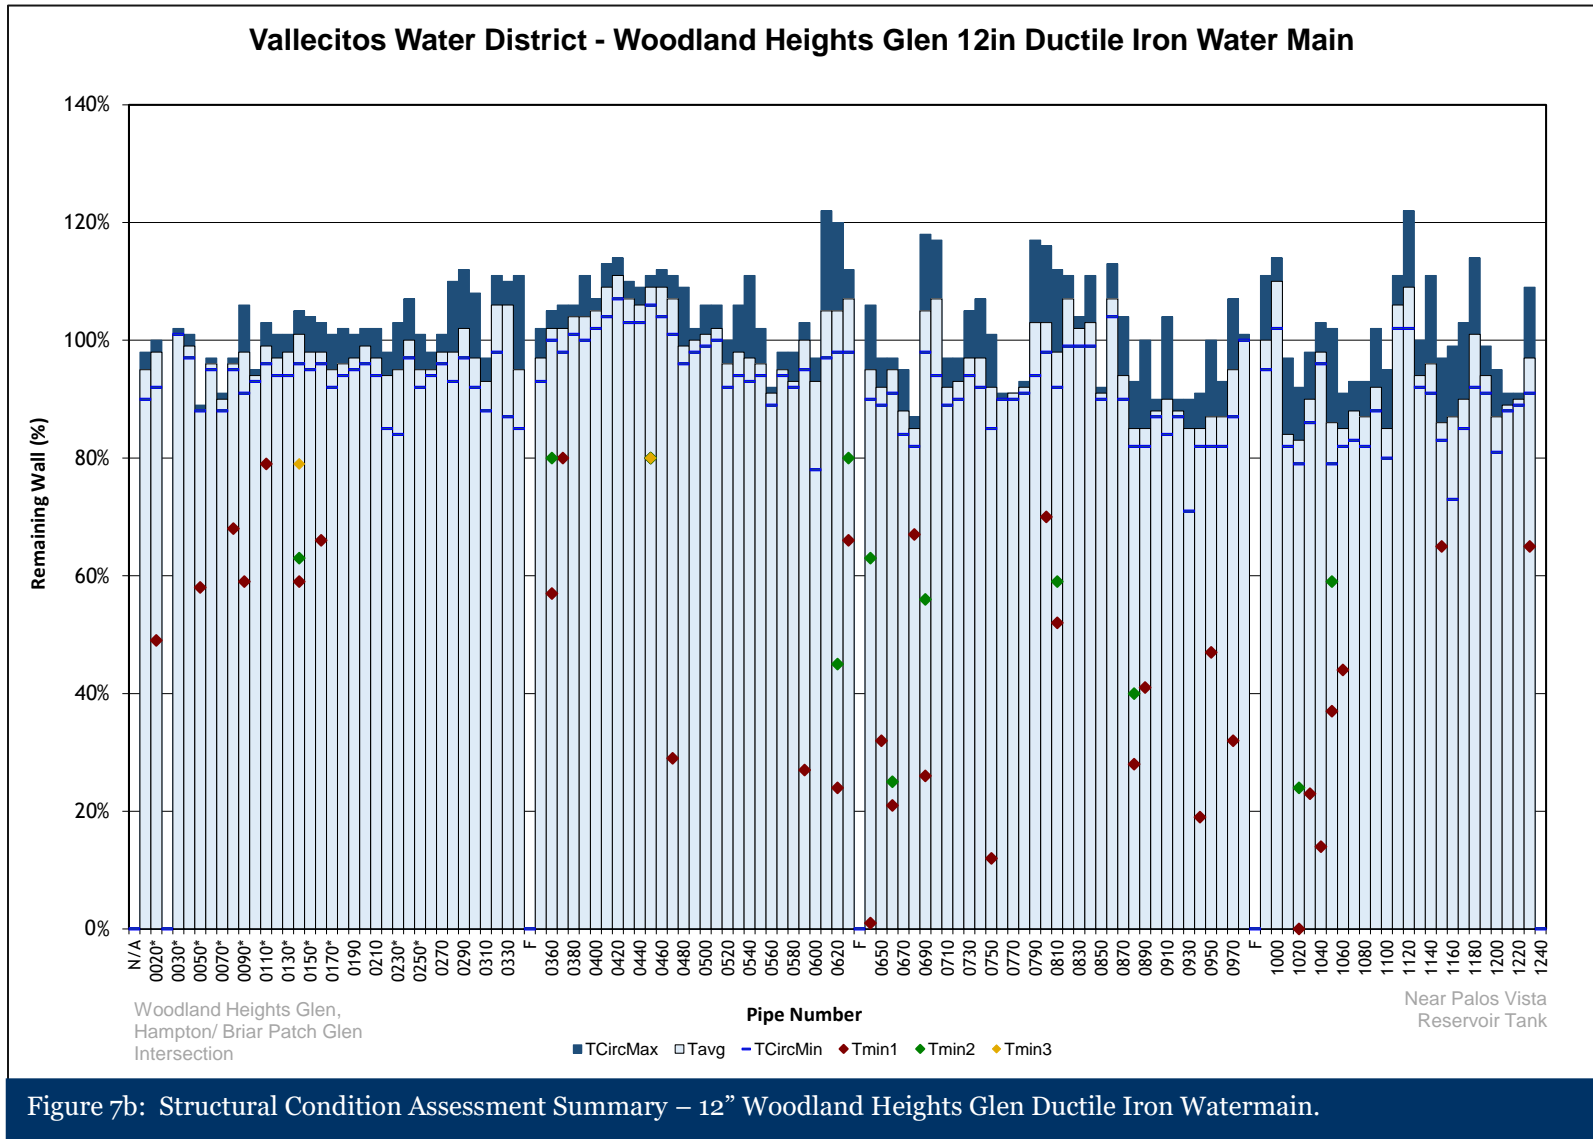
- The following 395ft (Pipes 0640 to 0870) exhibited a slight decrease in PARW across a number of pipes suggesting that this area may be experiencing low-level general corrosion (~5% deep). It is worth noting that three segments within this span, Pipes 0640, 0690 and 0750, are reported to contain a significant localized wall loss indication (1% RW, 26% RW and 12% RW respectively).

- A noticeable PARW decrease of up to 15% was observed in the last 612ft of the line (Pipes 0880 to 01240). While the PARW values in this region remained within the noted manufacturing tolerances, the increased incidence of localized corrosion with a large number of defects measuring deeper than 30% RW indicates that it is probable that a fair number of pipes in this area are experiencing general corrosion.

- **Pipe 0640:** 1% RW, 7:00 at 1060.32ft – This defect may be a through-hole.
- **Pipe 0750:** 12% RW, 5:30 at 1255.51ft
- **Pipe 0940:** 19% RW, 10:30 at 1559.47ft
- **Pipe 1020:** 0% RW, 10:00 at 1695.22ft – This defect was reported as area of interest (AOI) #1 following the preliminary analysis. This defect was excavated and verified as a through-hole. Additional information regarding the verification is provided in the following section.
- **Pipe 1040:** 14% RW, 12:00 at 1733.15ft

Figure 7b: Structural Condition Assessment Summary – 12” Woodland Heights Glen Ductile Iron Watermain.

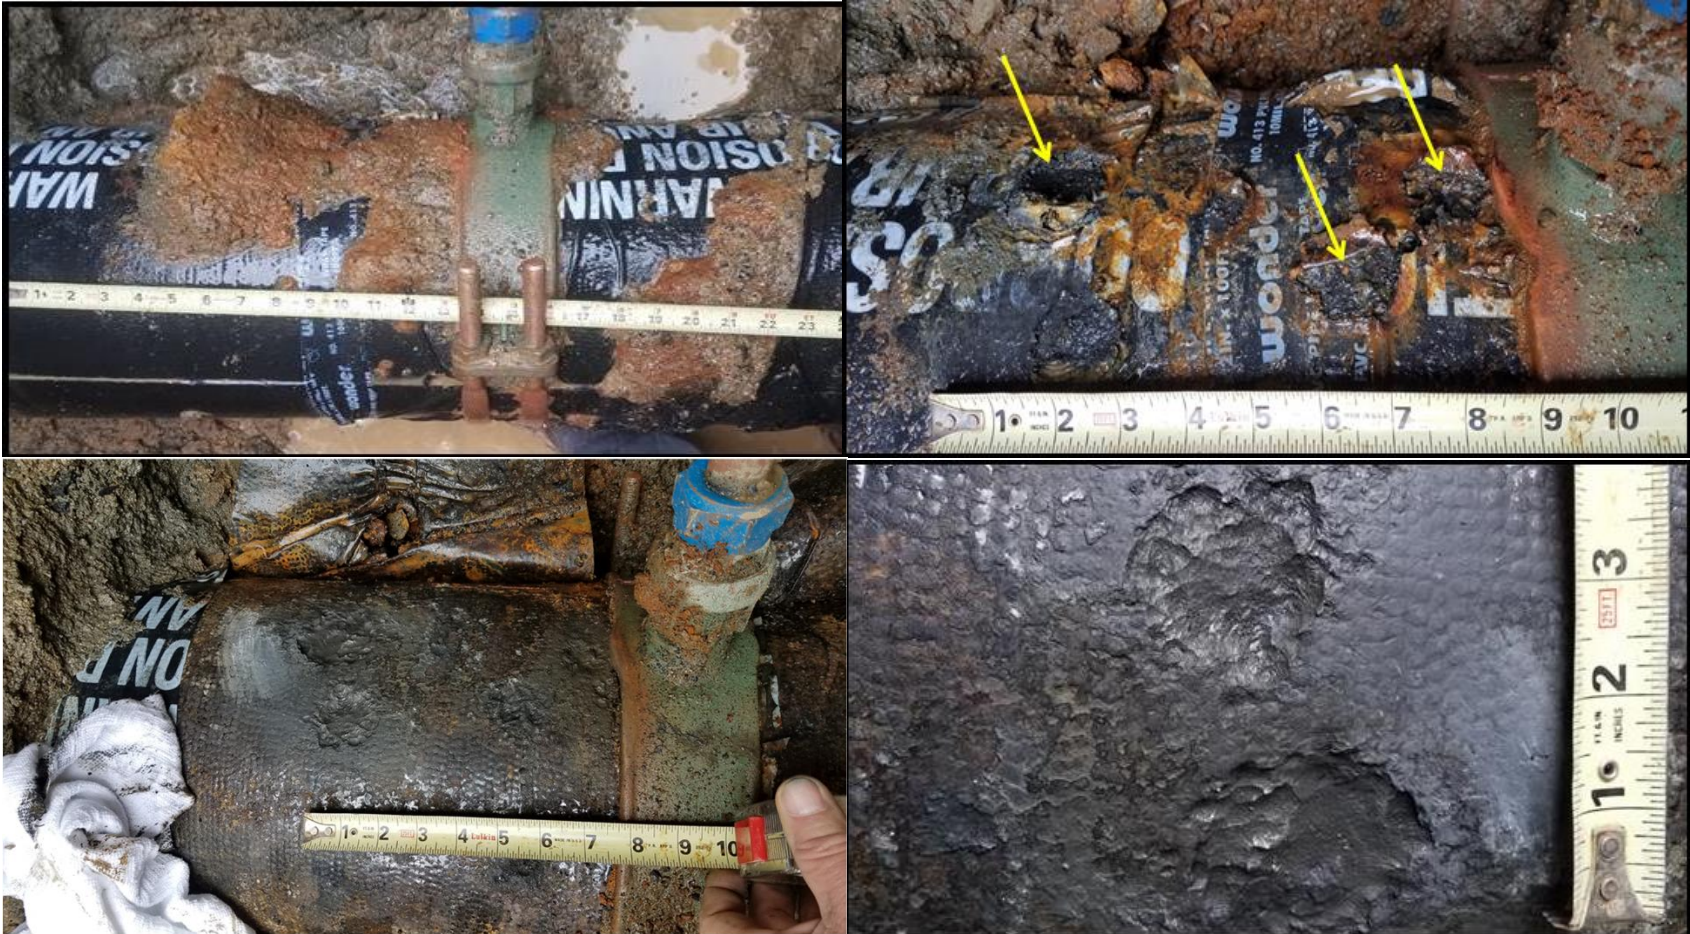
- **AOI #1:** 70% deep defect at 1665.6ft at 10:00 – “Large indication – other nearby wall loss”
- **AOI #2:** 60% deep defect at 1120.0ft at 10:30 – “Wall loss close to a feature, possible collar”

The feedback received from the two verifications was subsequently used by PICA to finetune the calibration during the comprehensive analysis of the RFT data. As a result, the values contained within this report supersede those submitted following the preliminary analysis. In general, the refined defect sizing was found to be 20% to 30% deeper than the preliminary results.

Figure B1: Verification photos of AOI #2 - Pipe 0690, 26% remaining wall (10:30) at 1149.63ft. To the right of the corrosion patch is a collar for a service connection. All photos are courtesy of RFYeager Engineering.
