**Highpoint Pipeline Condition
Assessment Vallecitos Water District
FINAL DRAFT
TECHNICAL MEMORANDUM**

Subject: **Summary of Condition Assessment Results and Recommendations**

HIGH POINT WATERLINE CONDITION ASSESSMENT

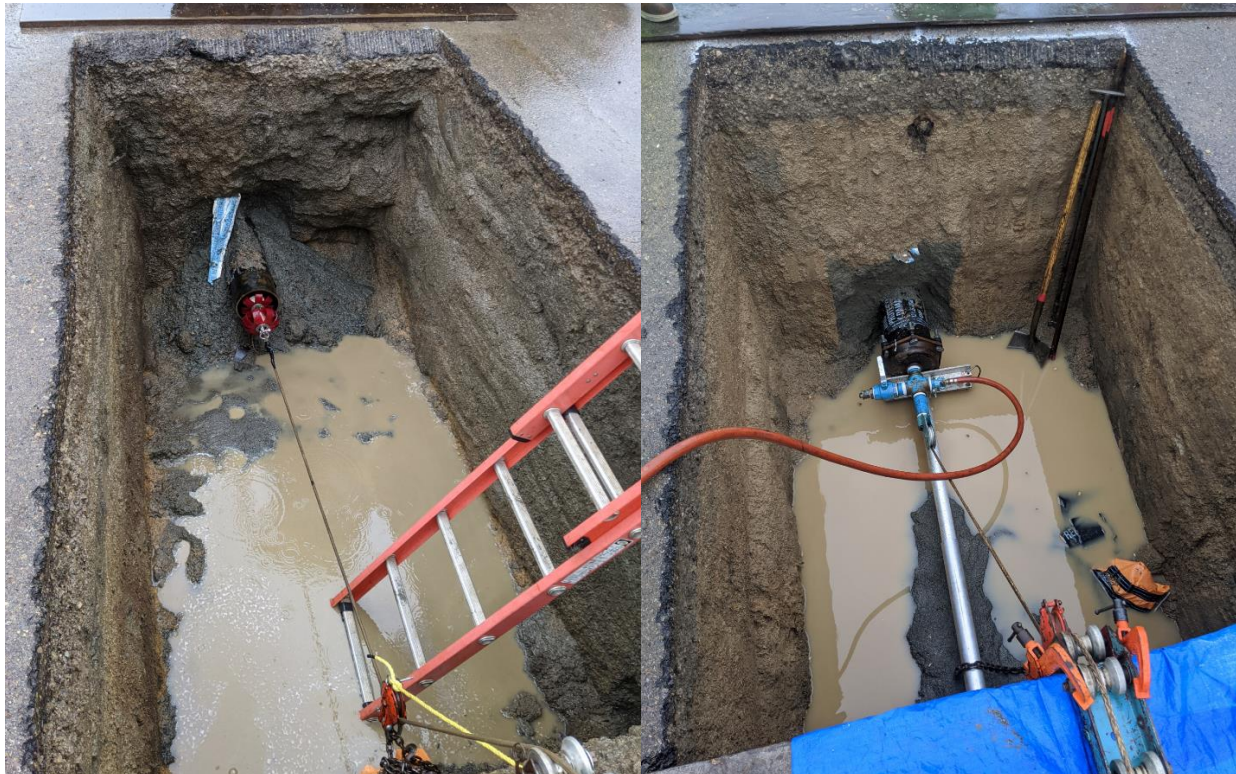
Figure 4: 8” KG access pits – Left: launch pit near the Hampton Glen intersection with the 8” SeeSnake visible just before commencing the 706ft run between both access pits; right: retrieve pit at the southeast end of Kensington Glen. as the 8” SeeSnake is being pulled through the line for the RFT inspection.

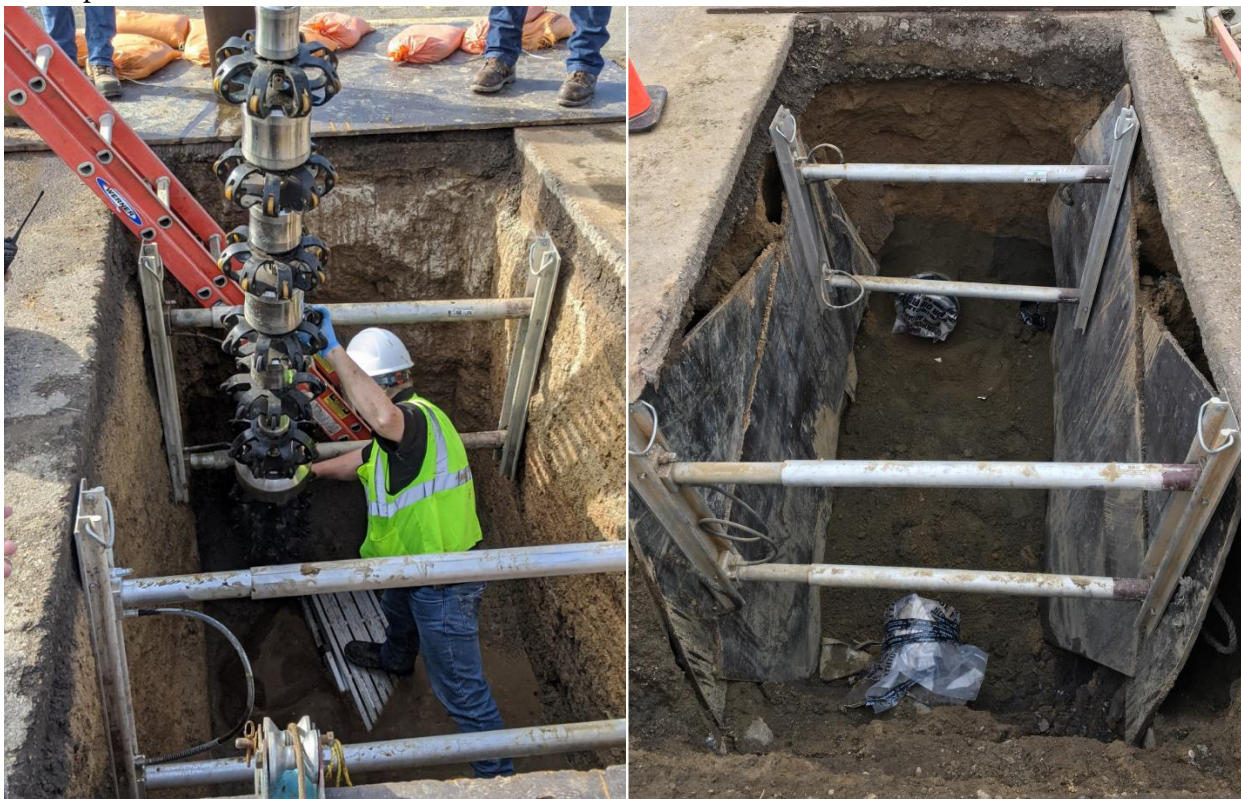
Figure 5: 12” WHG access pits – Left: launch pit near the Hampton Glen intersection with the 12” SeeSnake tool being lowered for insertion into the line; right: retrieve pit near the Palos Vista Reservoir tank prior to setting up the winch line.
